**Subject:** Updated Summary of Limited Soil Testing at Mabel Carver Elementary School, Stanton, California

**Subject:** EMF Testing at Mabel Carver Elementary School, Stanton, California

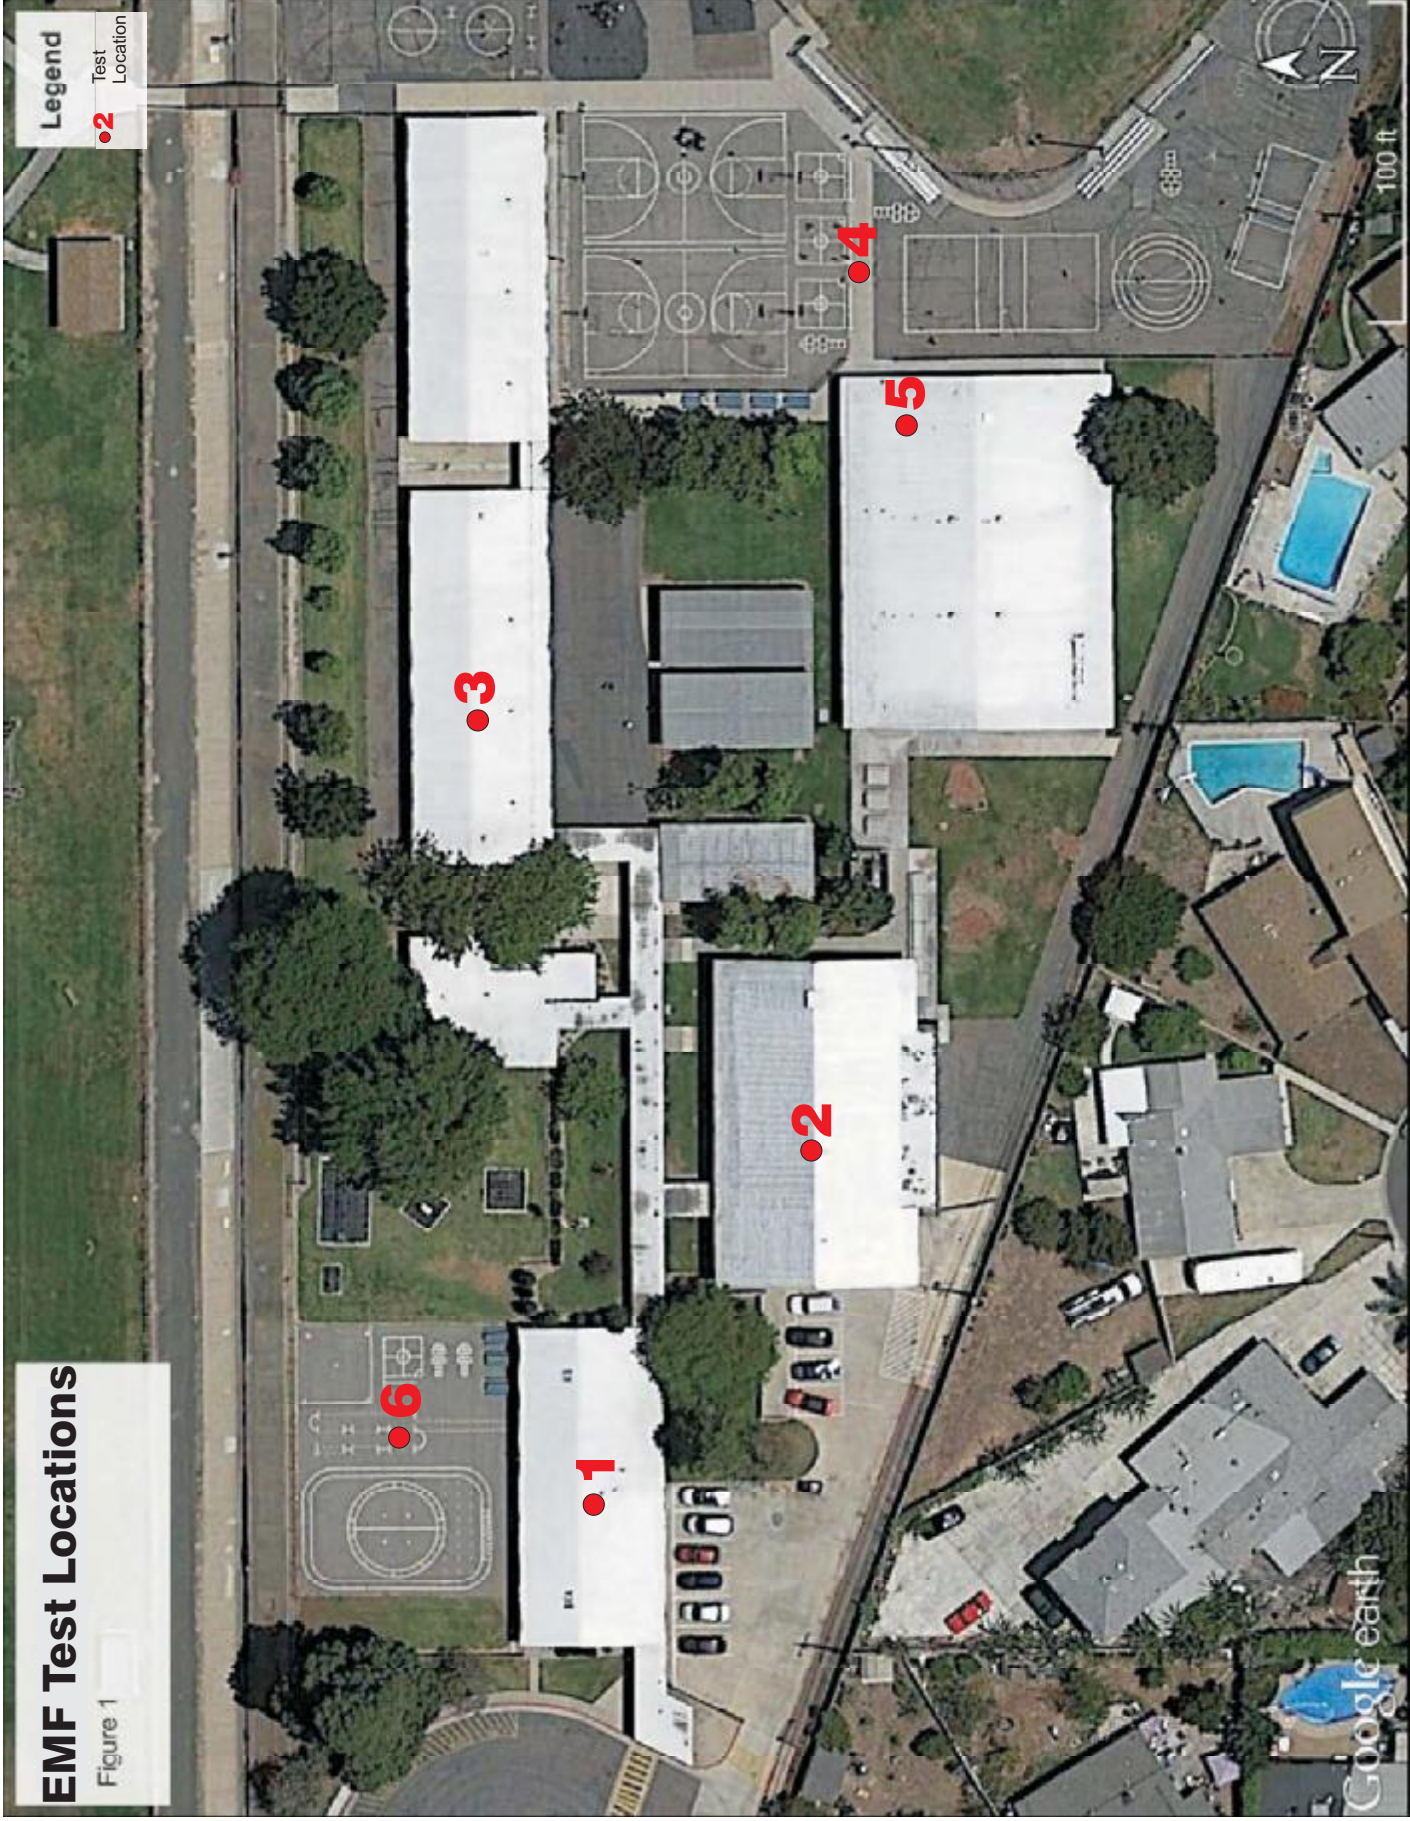
EMF readings were collected on the morning of March 20, 2015 from approximately three meters above the ground surface. The table below summarizes the EMF measurements and the attached figure shows the sample locations on the existing school site:

TEST ID	LOCATION	RESULTS (milligauss [mG])
1	Administration Building A	0.5
2	Multipurpose Room	0.5
3	Classroom B1	0.7
4	East Playground	0.3
5	Classroom in Building D	0.2
6	Kindergarten Playground	1.0
